FaultRock

Dr Brendan Duffy

GARAGE FLOOR SETTLEMENT
AT ...

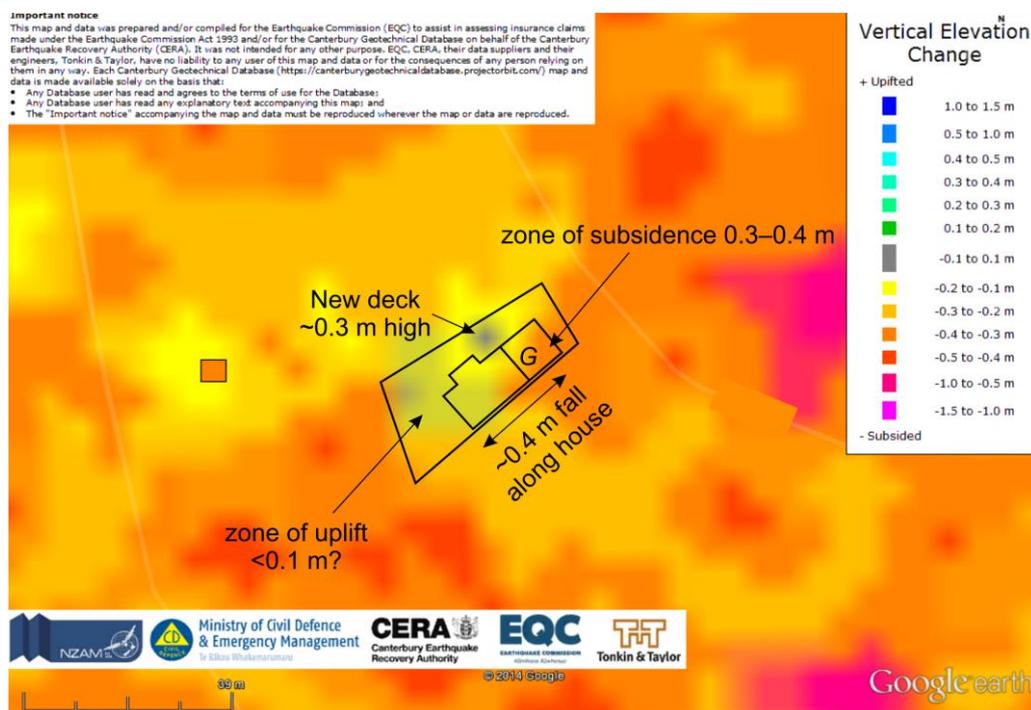
The _____ dwelling is located at _____, Parklands and surrounded by houses classified as rebuilds. Differential LiDAR maps available on the geotechnical database show that the area surrounding the dwelling subsided by <0.4 m at the eastern end and may have uplifted by <0.1 m at the western end of the property, during the earthquake series to June 2011 (Figure 1)

Figure 1. Differential Lidar map from the Canterbury Geotechnical Database. G – Garage. Note the general eastward increase in subsidence, and the sharp gradient passing below the eastern end of the house.

settlement reflects an underlying ground-surface-displacement that projects into the washroom/kitchen area of the house. Either option merits a rigorous inspection of the roof and the house foundations, but bending/bulging of the washroom floor and kitchen bench, along with gradients recorded by differential LiDAR (Figure 1) suggest that option b is more likely.

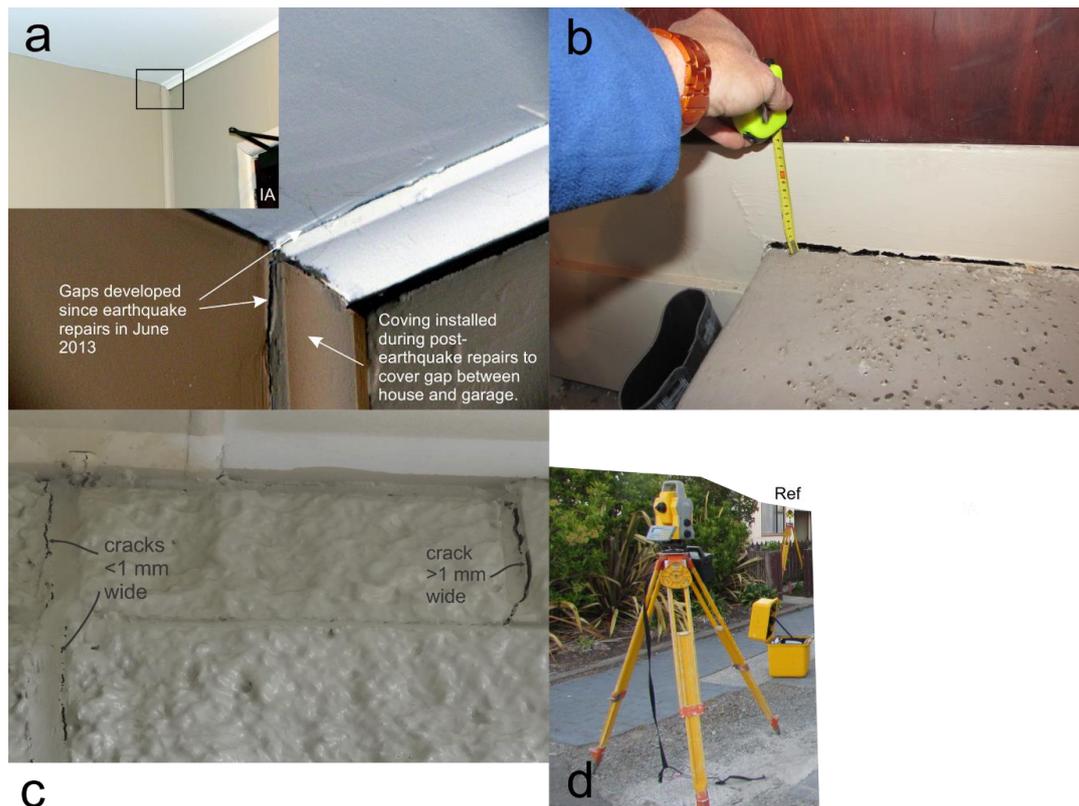
On the outside of the house, details of the brickwork at the connection of the garage and house veneer walls do not presently match, and indicate a downward displacement of the garage relative to the house. A crack opened on both inside and outside walls at these localities during the Canterbury earthquake sequence; it was especially obvious on the inside, next to the internal access door. This internal crack was 'repaired' by covering it with timber coving during EQC earthquake repairs in June 2014. The opening is now once-again visible (Figure 2a–c), having reopened during a $M_w 4.5$ earthquake in early December 2014. External cracks at this location have also been reactivated.

Figure 2. a) Reactivation of earthquake damage on internal walls, SW corner of garage. b) earthquake-related gap between concrete step and internal access door. c) new cracks in repaired external join of house and garage. Crack on right of picture is not reactivated, but a new crack formed in December 2014. d) survey set up. Note reference station to left of garage. Photo d altered to protect client privacy.

- 3) A wide crack opened between the house and the garage during the Canterbury earthquake sequence, and was 'repaired' by covering with timber coving during EQC earthquake repairs in June 2013. The opening is now once-again visible (Figure 2) due to further differential settlement after the repair. This settlement appears to have occurred during a Mw 4.5 earthquake (id 2014p933966) on Saturday, December 13th 2014. The nature of the damage is excessive for the light shaking intensities reported from Parklands, and suggests that the present foundation has a low capacity to resist deformation.

On the basis of this survey, and specifically points 1–3 above, I recommend a full engineering evaluation of both house and garage, to inform an appropriate decision of further action. Given the pattern of differential subsidence, it would be appropriate to have the garage floor checked for sub-floor cavities.

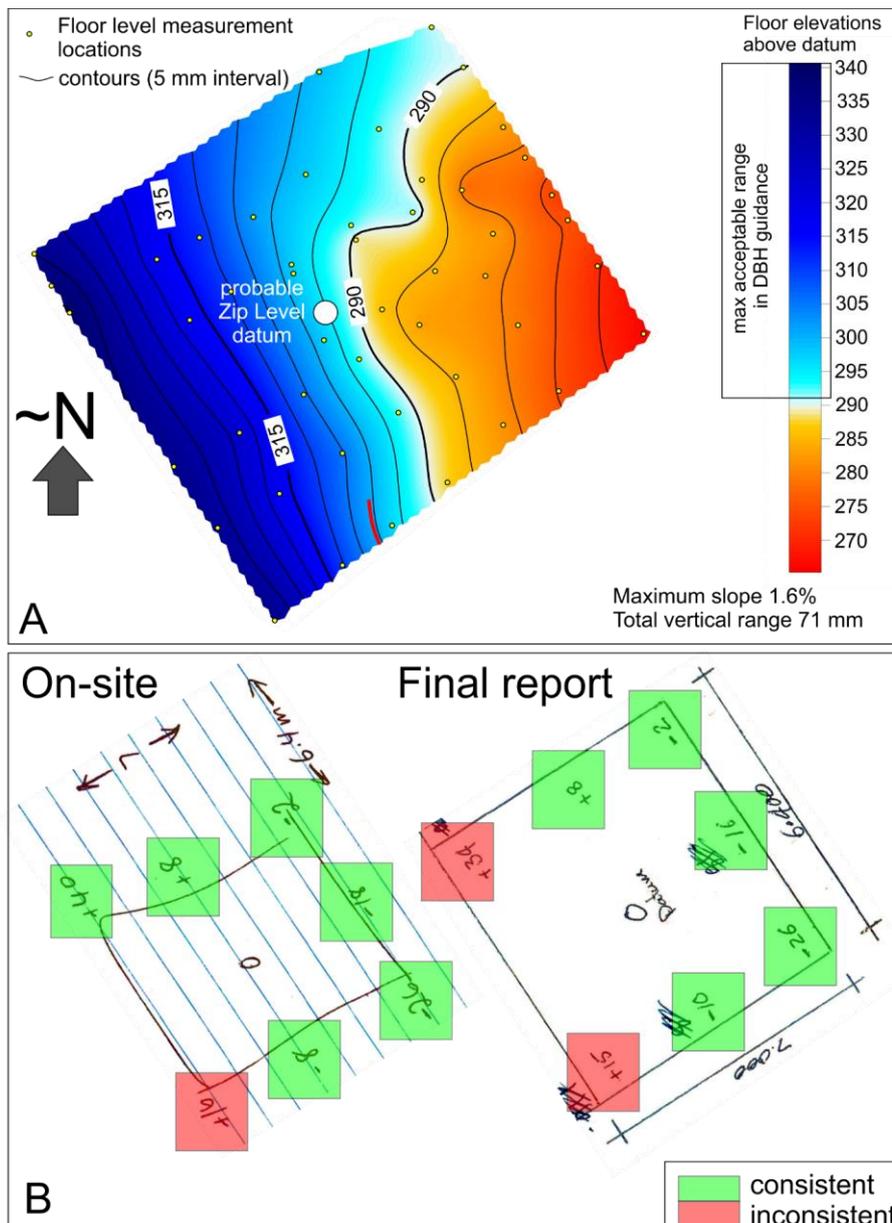
The floor levels within the garage measured between 265 and 336 mm above the instrument position, a total range of 71mm. The entire slab slopes to the east, with a maximum full-width gradient of 0.95%. The western part of the slab dips more steeply, with a maximum slope over 2 m of 1.6%. This steep slope is located immediately abutting the house perimeter foundation.

Apart from the SW corner of the garage, where the EQR survey was ~25 mm too low (well in excess of Zip Level instrumental error), the results of this survey are consistent with the EQR data *provided on-site*. They are substantially less consistent with Fletcher EQR's final report data. The total station survey result of +40 mm in the SW corner of the garage is internally consistent with the slope defined by multiple other measurements in that quadrant, and so is more reliable than either single-point Fletcher EQR survey result.

Figure 3. A) Map summarizing the results of re-surveying of garage floor levels at _____. Blue tones define the acceptable range. B) Relative floor levels for garage floor provided by previous surveyor on-site and in post-visit report. Note the variation between on-site and final records, particularly the 6 mm change in the NW corner. Note also the clear inconsistency of the measurement in the south corner, compared with some six measurements taken in the present survey.

For a type-C building, such as the _____ garage, the DBH guidance does not require structural repair where the vertical differential settlement is less than 50 mm across the space, and the floor slope is less than 1:200 (0.5%) between any two points >2 m apart. The garage floor at the _____ residence is out of level by a maximum of 71 mm (40% over the minimum criterion for structural repair), and the maximum floor slope observed over 2 m in this survey is 1.6% (>300% over the minimum criterion for structural repair).
